DR® Lawn Mower SP 26 and SP 30

Transmission Replacement Instructions – Part# 391261

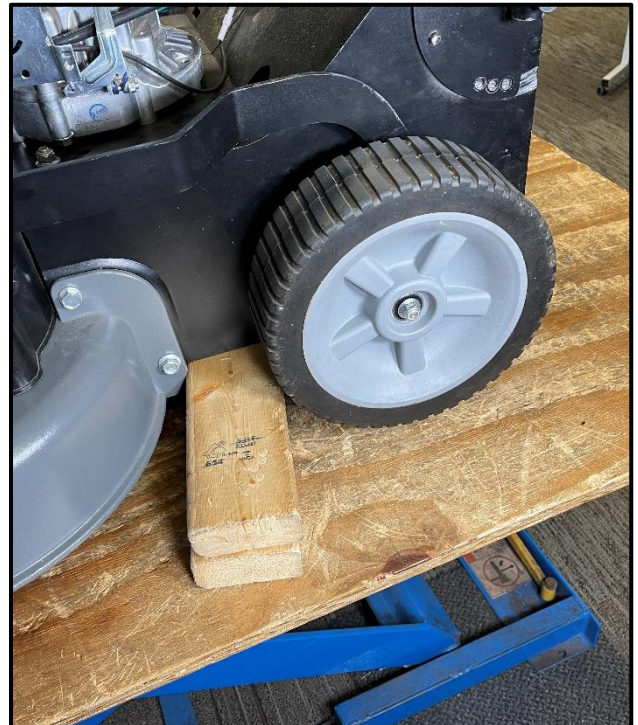
Figure 1

1. With the deck raised, slide blocking under the Main Frame, in front of the rear wheels. Lower the deck to take the weight off the rear wheels and set the handlebars to the upright storage position (**Figure 1**).
2. Remove both rear wheels using a 9/16" Wrench.
3. Remove the Snap Ring from both drive gears using a pair of Snap Ring Pliers. Then remove the gear and plastic backing (**Figure 2**).

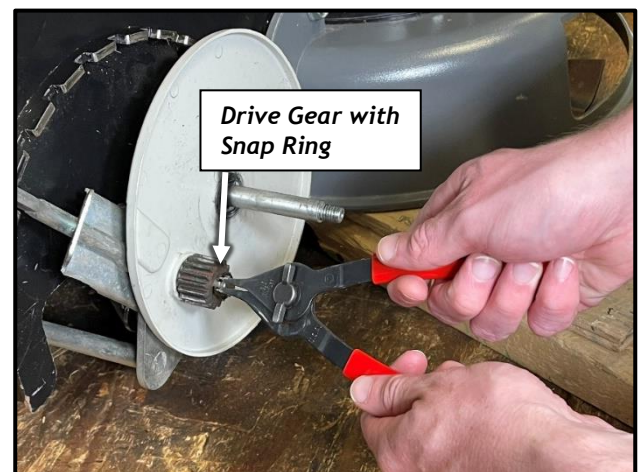
Figure 2

Note: Be careful not to overstretch the Snap Ring during removal. Open it just enough to slide off the shaft.

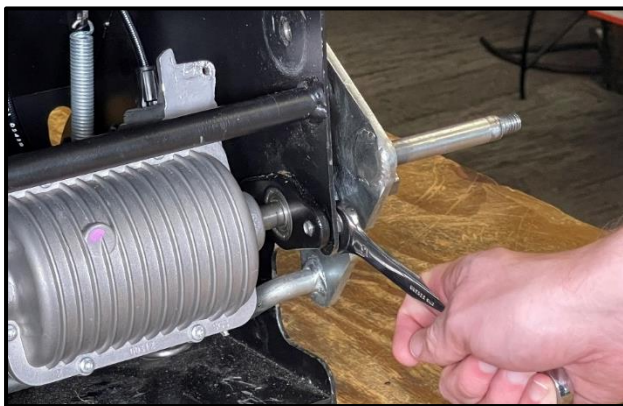
Figure 6

3. Remove the Drive Belt as described by your S&O Manual.
4. Remove the two bolts that connect the Axle to the Frame Weldment. Use a 7/16" Wrench on the nut, and a 3/8" Wrench or socket on the bolt Head (Figure 4).
5. Remove the clip off the Height Adjust Bar by the front tires using a Flat Head Screwdriver. (Figure 5).
6. Remove the two Axle mounting bolts from each side using an Open-Ended 1/2" Wrench (Figure 6).

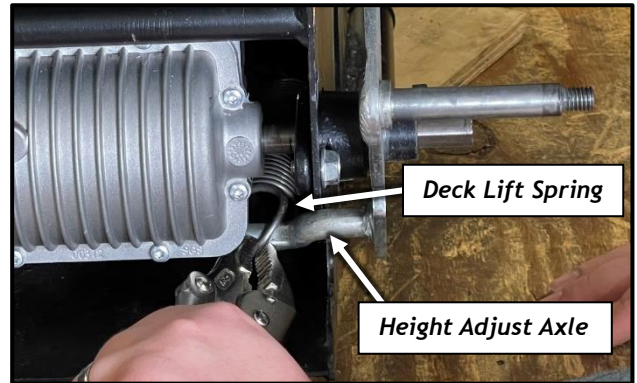
Figure 3

2. Using a Spring Puller or Locking Pliers, take the end of the Deck Lift Spring off the Height Adjust Axle (Figure 3).

Note: This requires a good deal of force, so have a helper brace the machine so it does not tip.

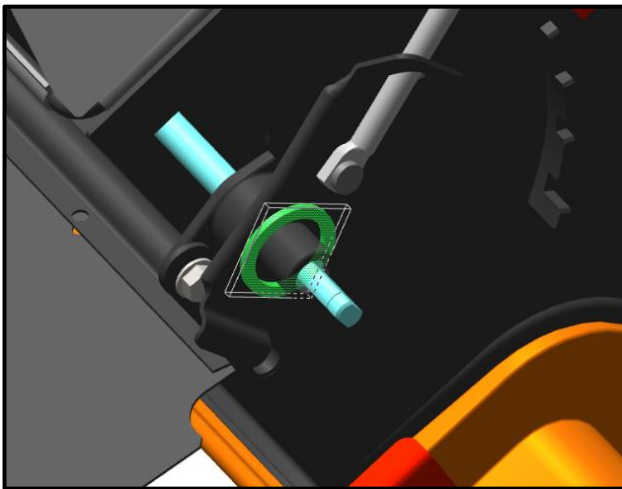
Figure 10

- When doing Step 9 in reverse, there may be a Washer that must be reinstalled on your machine between the Height Adjust Lever and the Axle Weldment (**Figure 10**). This is not present on all machines.

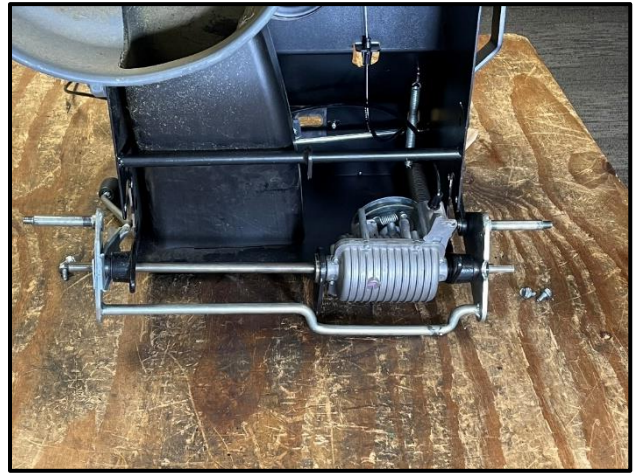
Figure 7

- Slide the whole Axle and Transmission assembly out as one piece. (**Figure 7**).

Note: It may be easier to remove the assembly if the machine is tipped back more than in previous steps, so have a helper assist to improve stability.

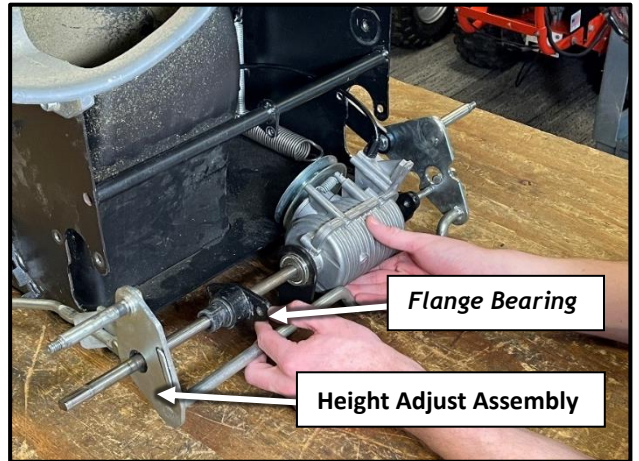
Figure 8

- Push the Flange Bearing back so that you can shift the Transmission and Axle to separate them from the Height Adjust Assembly (**Figure 8**).
- Shift the Transmission and Axle to the left, allowing you to angle the right-hand side away from the Height Adjust Weldment. Shift the Axle back to the right and separate the Transmission from the Height Adjust Assembly (**Figure 9**).

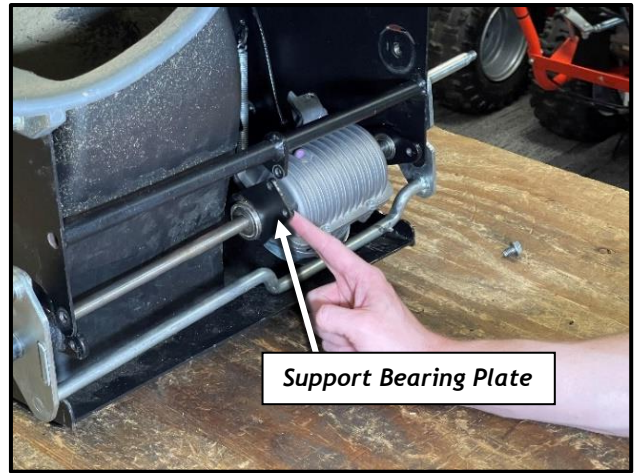
Figure 11

2. When doing Step 6 in reverse, ensure that the Support Bearing Plate is pushed up next to the Transmission when inserting the assembly back into the machine. It will catch on to the Discharge Chute and cause the assembly to not fit properly if not in the right position (**Figure 11**).
